**Flood Control Project Maintenance  
Levee Inspections****LMA District Cover Sheet****Spring 2013 Levee Inspection Results****Reclamation District No. 0150 Merrit Island**

**Spring 2013 Levee Inspection Results**

**Reclamation District No. 0150 Merrit Island**

Waterway			Bank	Unit Miles
Unit No. 01 Sutter Slough			Left	0.54
	Spring (March - May)	Summer (June - August)	(September - November) Fall	Winter (December - February)
Unit Maintenance Rating (Fall Only)				
Date of Inspection	03/14/2013 - 03/14/2013			
DWR Inspector	Pavel Kazi			
Accompanied By

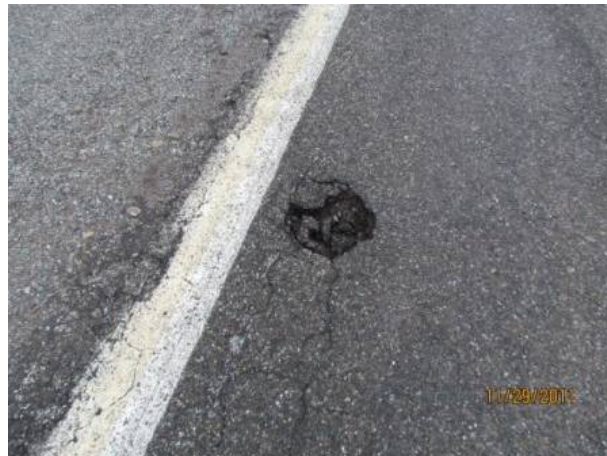
pkazi\_s\_20130304\_644.jpg

Depression was found on the crown of the levee looking downstream.

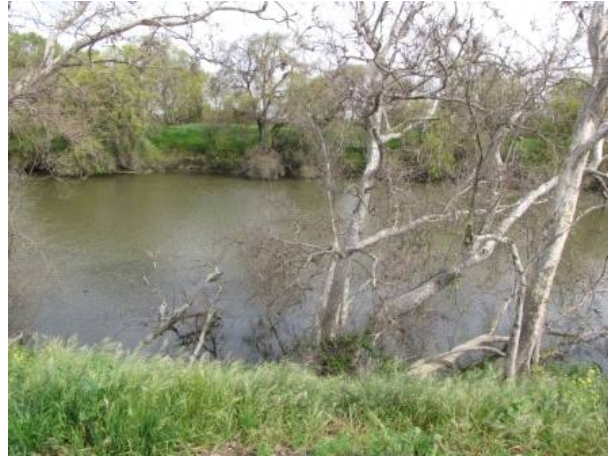
pkazi\_s\_20130304\_592.jpg

View of tree stumps on the waterward slope.

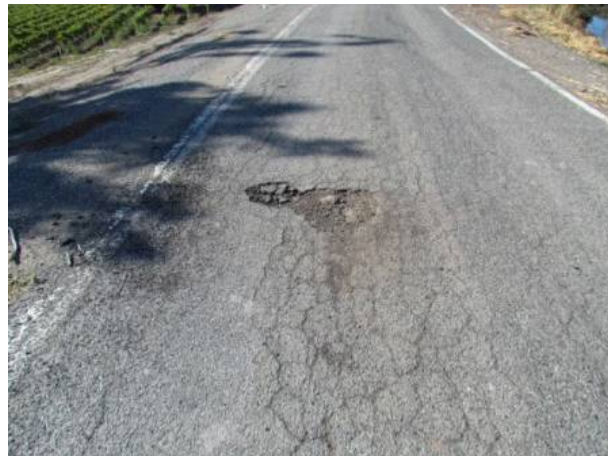
pkazi\_s\_20130304\_660.jpg

Crown depression was found on the access road looking downstream.

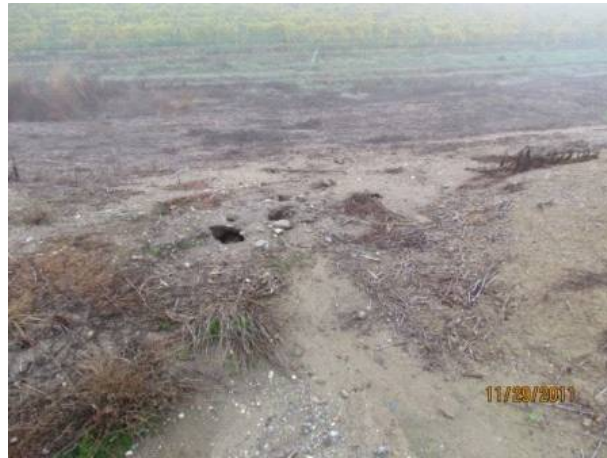
Levee Mile Report Line	26
Start Levee Mile	3.34
End Levee Mile	3.34
Location	Land Side
Category	
Item	Animal Control
Rodent holes were found on the landside of the levee looking downstream.	
pkazi_s_20130304_639.jpg

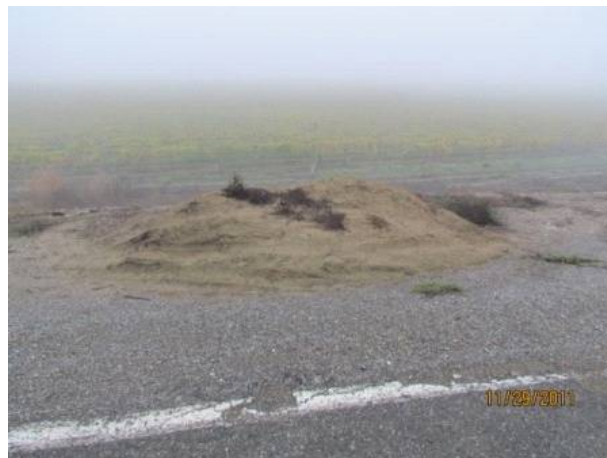
Levee Mile Report Line	27
Start Levee Mile	3.34
End Levee Mile	3.34
Location	Land Side
Category	
Item	Encroachments
Material was found on the landside of the levee looking downstream.	
pkazi_s_20130304_641.jpg

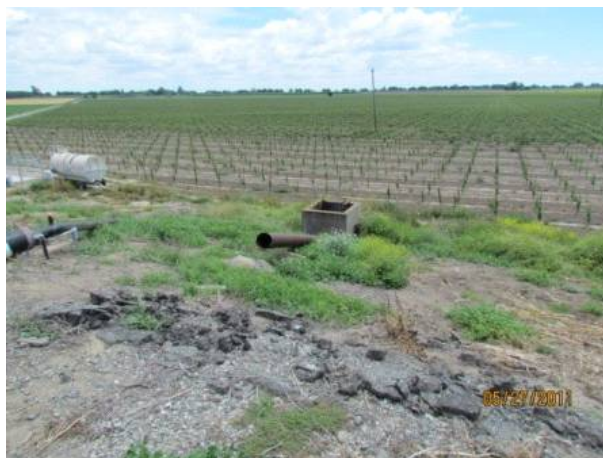
Levee Mile Report Line	28
Start Levee Mile	3.34
End Levee Mile	3.34
Location	Land Side
Category	
Item	Encroachments
An abandoned pipe was located on the landside of the levee. The picture was taken from the crown looking downstream.	
pkazi_s_20130304_606.jpg

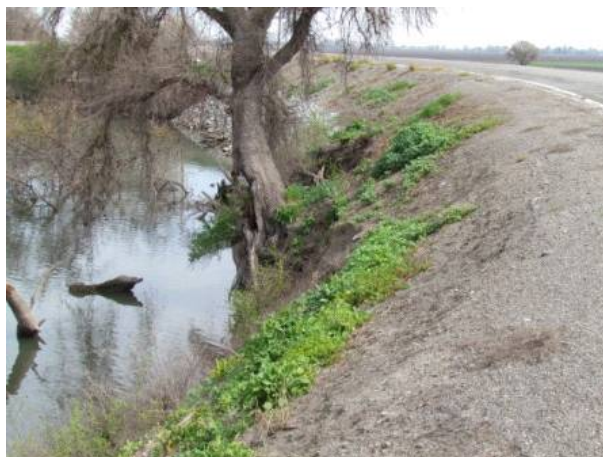
Levee Mile Report Line	29
Start Levee Mile	3.37
End Levee Mile	3.37
Location	Water Side
Category	
Item	Erosion / Bank Caving
Erosion was found on the waterside toe of the levee looking upstream during spring 2013 inspection.	
pkazi_s_20130320_922.JPG

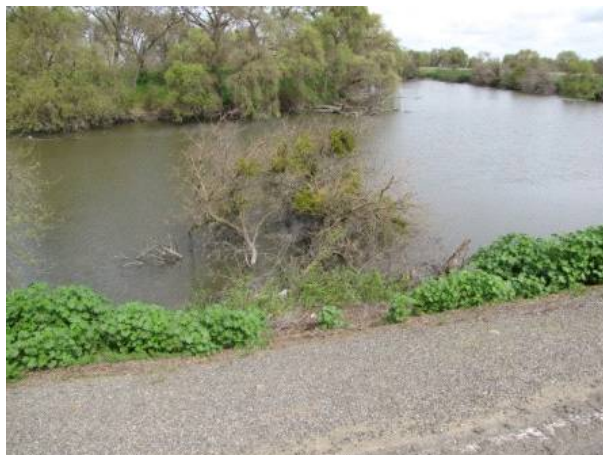
Levee Mile Report Line	30
Start Levee Mile	3.41
End Levee Mile	3.41
Location	Water Side
Category	
Item	Trim / Thin Trees
View of tree stumps on the waterside slope looking upstream.	
pkazi_s_20130304_598.jpg

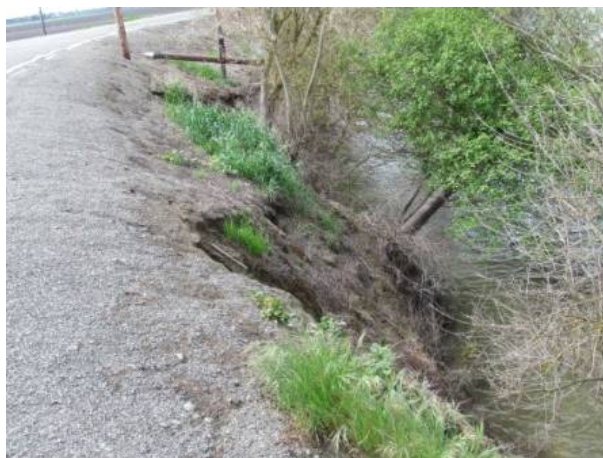
pkazi\_s\_20130304\_662.jpg

Erosion was found on the waterside of the levee looking downstream.

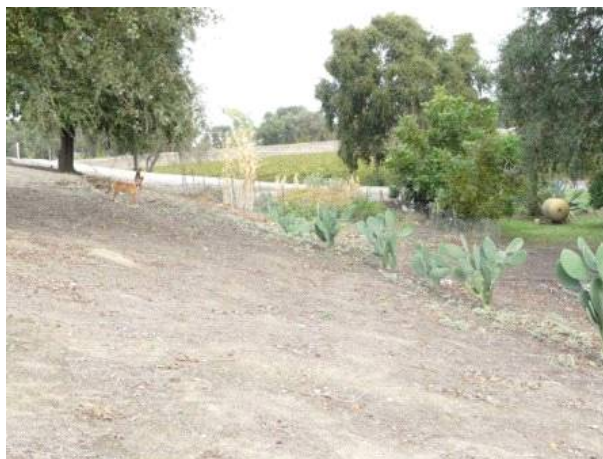
pkazi\_s\_20130304\_610.JPG

Levee Mile Report Line	32
Start Levee Mile	3.50
End Levee Mile	3.54
Location	Land Side
Category	
Item	Vegetation

Landscaping & garden on landward slope of levee at LM 3.50 to LM 3.54.

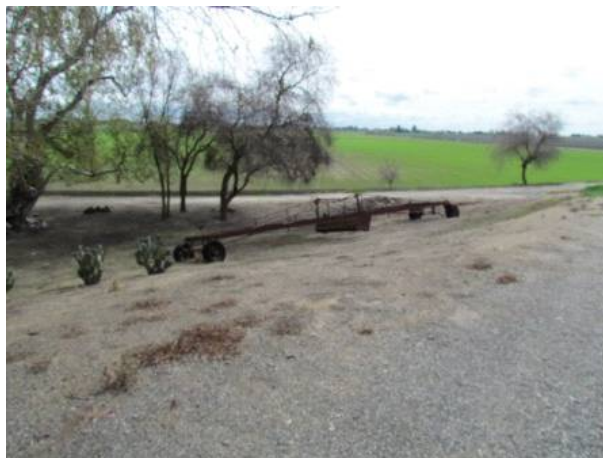
pkazi\_s\_20130304\_661.jpg

Levee Mile Report Line	33
Start Levee Mile	3.51
End Levee Mile	3.51
Location	Land Side
Category	
Item	Encroachments

Equipment was found on the landside of the levee looking downstream.

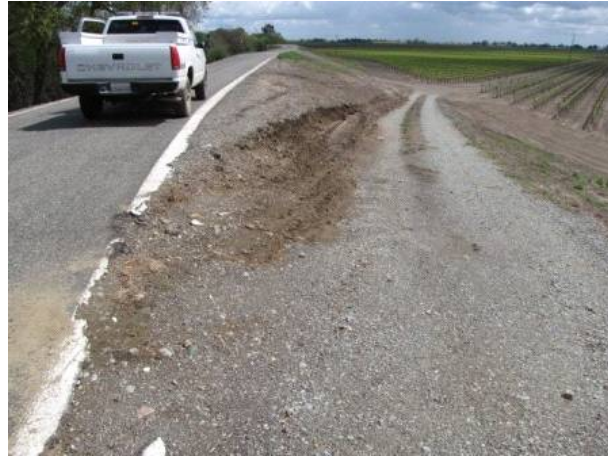
Levee Mile Report Line	34
Start Levee Mile	3.75
End Levee Mile	3.75
Location	Land Side
Category	
Item	Slope Stability
Repair minor damage to levee slope along landward ramp at LM 3.75.	
pkazi_s_20130304_663.jpg

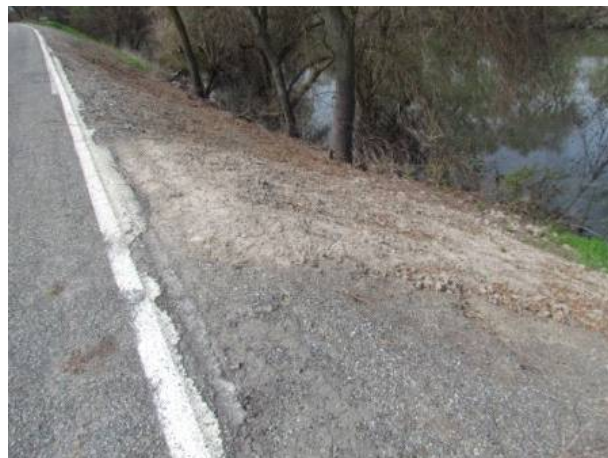
Levee Mile Report Line	35
Start Levee Mile	3.77
End Levee Mile	3.77
Location	Water Side
Category	
Item	Slope Stability
Slope instability was repaired by the LMA on the waterside slope of the levee looking downstream.	
pkazi_s_20130320_924.JPG

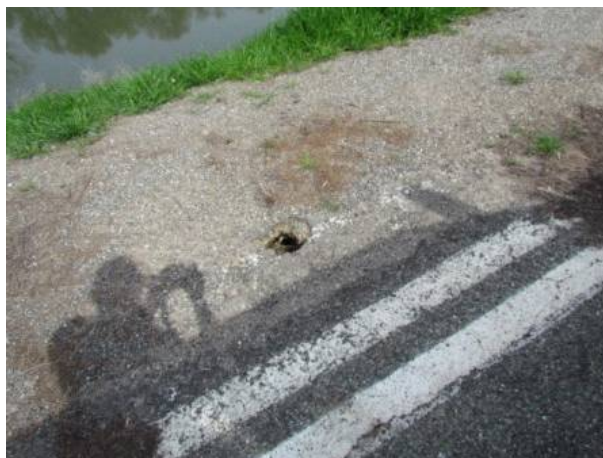
pkazi\_s\_20130320\_923.JPG

An animal hole was found on the waterside shoulder of the levee looking upstream during spring 2013 inspection.

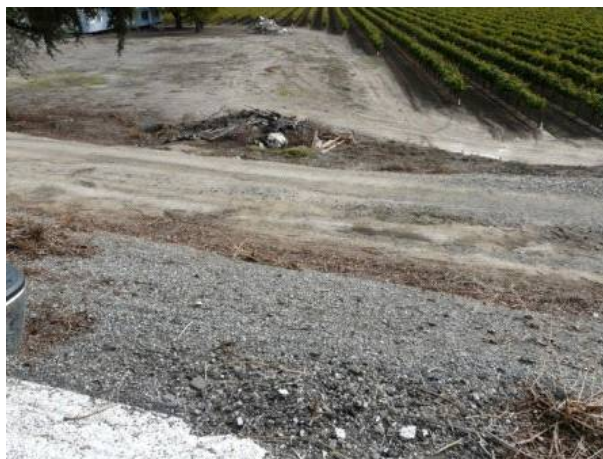
pkazi\_s\_20130304\_611.JPG

Levee Mile Report Line	38
Start Levee Mile	3.95
End Levee Mile	3.95
Location	Land Side
Category	
Item	Encroachments

Debris pile on landward slope at LM 3.95.

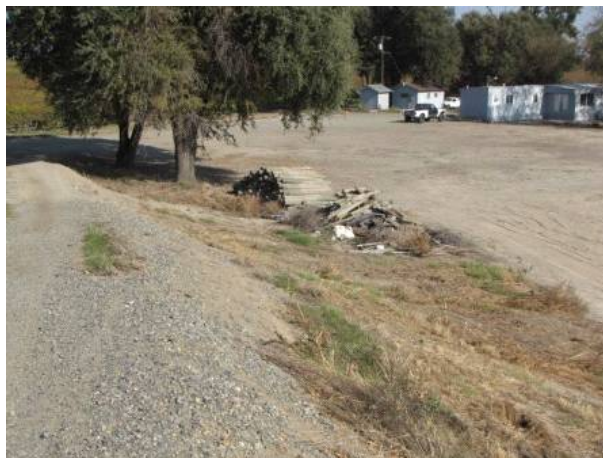
pkazi\_s\_20130304\_612.jpg

Levee Mile Report Line	38
Start Levee Mile	3.95
End Levee Mile	3.95
Location	Land Side
Category	
Item	Encroachments

Updated view of material piled at the toe of the levee as of fall 2009.

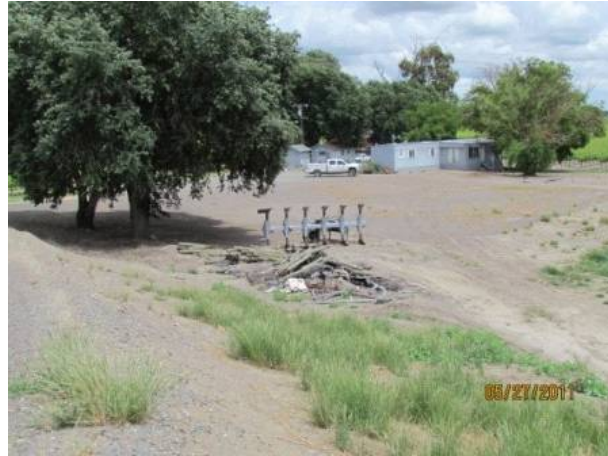
Levee Mile Report Line	38
Start Levee Mile	3.95
End Levee Mile	3.95
Location	Land Side
Category	
Item	Encroachments
Debris found on the landside of the levee during Spring 2011 inspection. The picture was taken from the crown looking upstream.	
pkazi_s_20130304_613.jpg

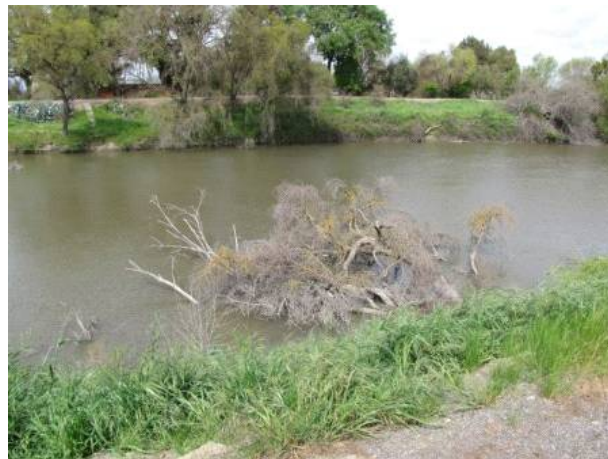
Levee Mile Report Line	40
Start Levee Mile	4.35
End Levee Mile	4.35
Location	Water Side
Category	
Item	Trim / Thin Trees
View of tree stumps on the waterward slope.	
pkazi_s_20130304_605.jpg

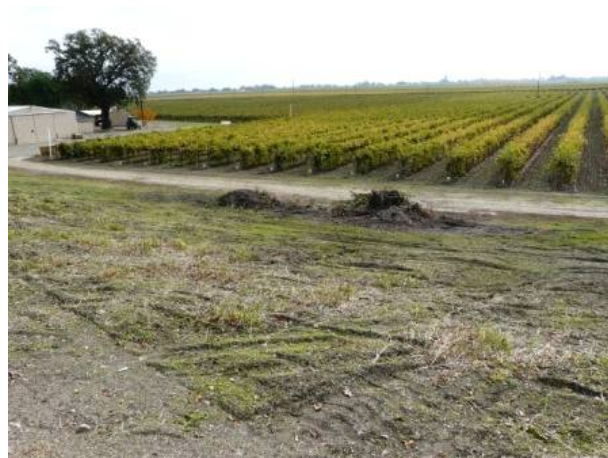
Levee Mile Report Line	41
Start Levee Mile	4.46
End Levee Mile	4.46
Location	Land Side
Category	
Item	Encroachments
Remove pruning pile on landward slope at LM 4.46.	
pkazi_s_20130304_616.JPG

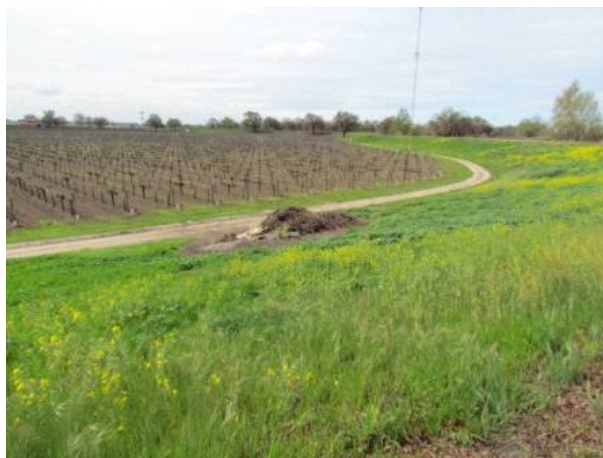
pkazi\_s\_20130304\_617.jpg

Pruning was found on the landside of the levee looking downstream.

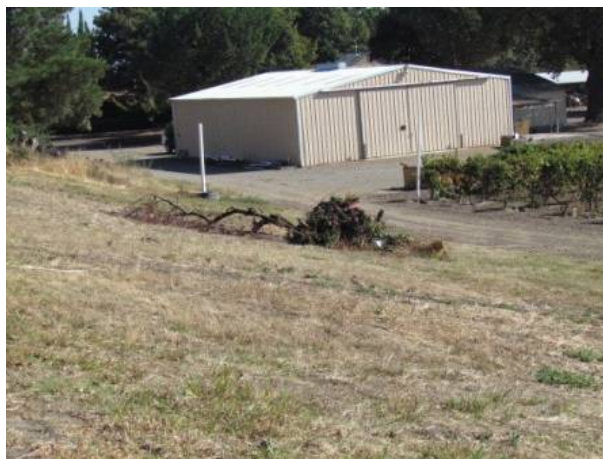
pkazi\_s\_20130304\_618.jpg

Levee Mile Report Line	41
Start Levee Mile	4.46
End Levee Mile	4.46
Location	Land Side
Category	
Item	Encroachments

Pruning was found on the landside of the levee looking upstream. This picture was taken during fall 2012 inspection.

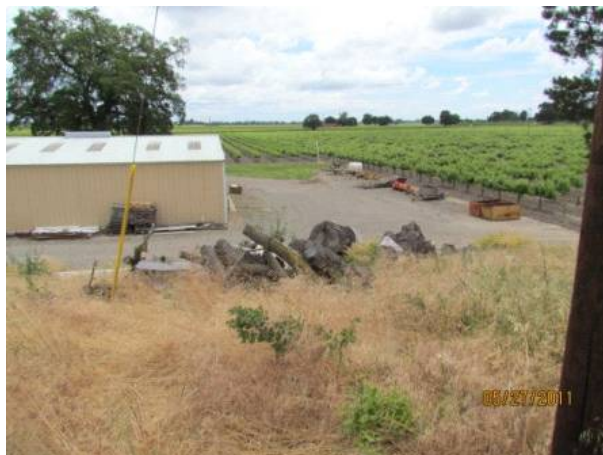
pkazi\_s\_20130304\_619.jpg

Levee Mile Report Line	42
Start Levee Mile	4.51
End Levee Mile	4.51
Location	Land Side
Category	
Item	Encroachments

Tree branches were found on the toe of landside of the levee. The picture was taken from the crown looking downstream.

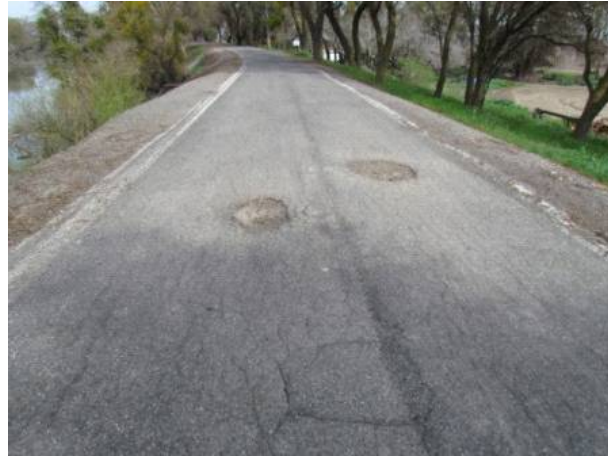
Levee Mile Report Line	44
Start Levee Mile	4.95
End Levee Mile	4.95
Location	Crown
Category	
Item	Crown Surface / Depressions / Rutting
Crown depressions were found during spring 2013 inspection looking upstream.	
pkazi_s_20130320_925.JPG

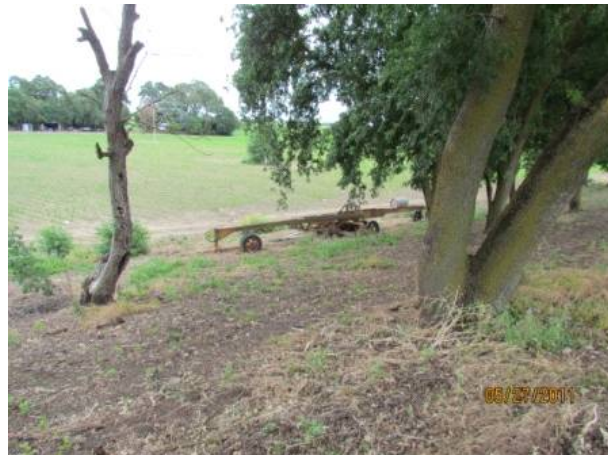
Levee Mile Report Line	45
Start Levee Mile	4.98
End Levee Mile	4.98
Location	Land Side
Category	
Item	Encroachments
Equipment on the landside toe of the levee. The picture was taken from crown looking downstream.	
pkazi_s_20130304_582.jpg

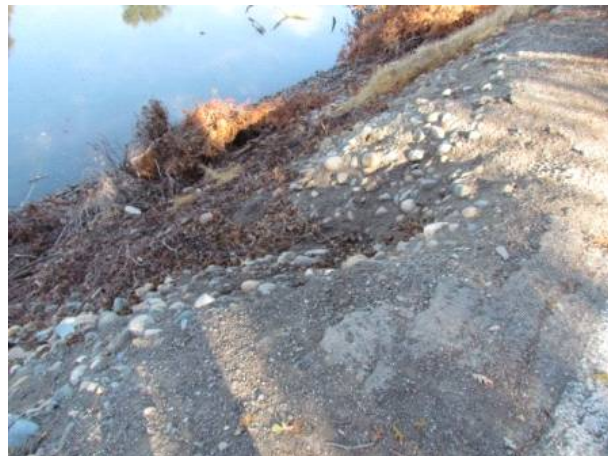
Levee Mile Report Line	46
Start Levee Mile	5.08
End Levee Mile	5.08
Location	Water Side
Category	
Item	Slope Stability
Slope instability was found on the waterside of the levee looking upstream.	
pkazi_s_20130304_604.jpg

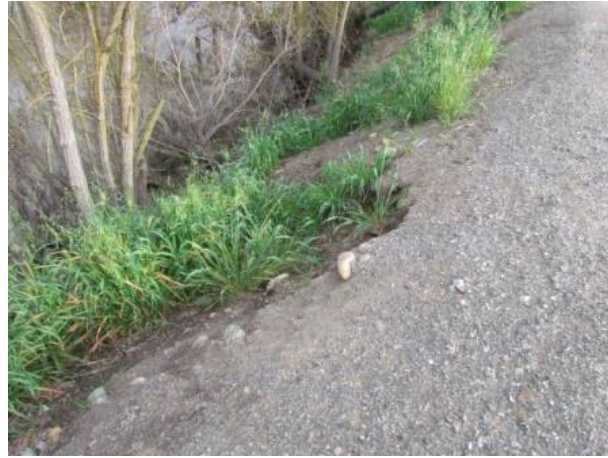
pkazi\_s\_20130304\_578.jpg

Slope instability was found on the waterside of the levee looking upstream.

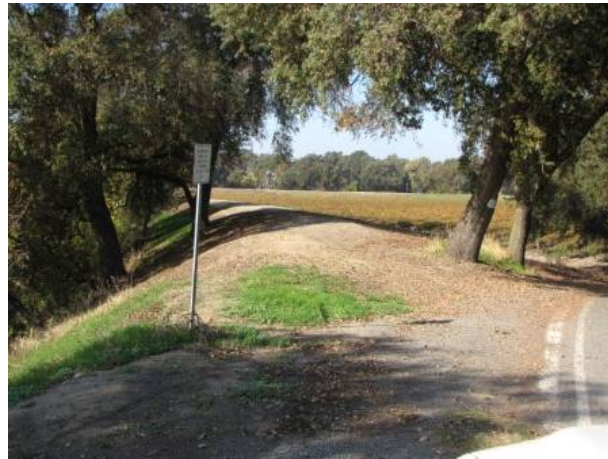
pkazi\_s\_20130304\_671.jpg

Levee Mile Report Line	49
Start Levee Mile	5.22
End Levee Mile	5.22
Location	Crown
Category	
Item	Crown Surface / Depressions / Rutting

View of varying elevations in the crown of the levee at the transition from county road to access road.

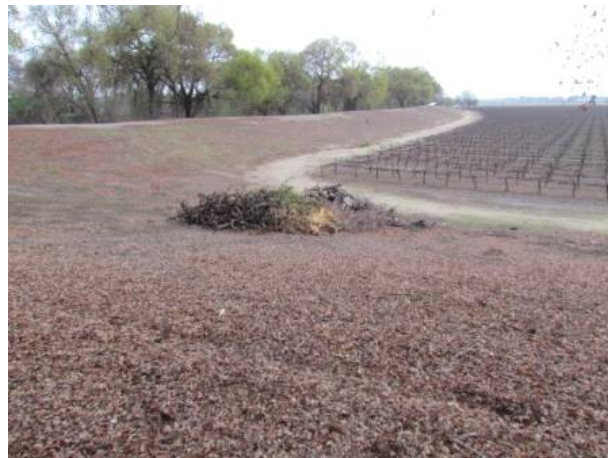
pkazi\_s\_20130304\_584.jpg

Levee Mile Report Line	50
Start Levee Mile	5.61
End Levee Mile	5.61
Location	Land Side
Category	
Item	Encroachments

Prunings were found on the landside of the levee looking upstream.

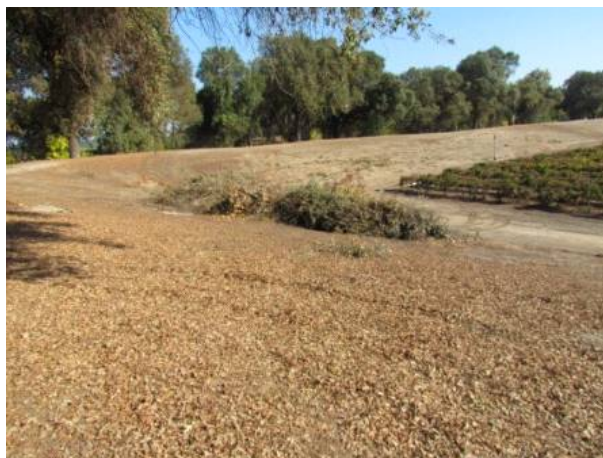
pkazi\_s\_20130304\_585.jpg

Pruning was found on the landside toe of the levee looking upstream. This picture was taken during fall 2012 inspection.

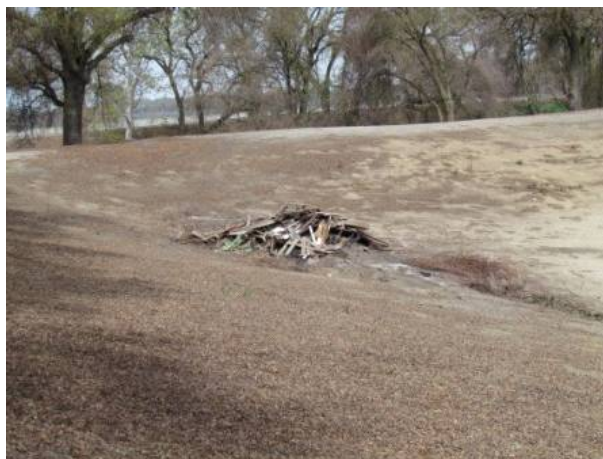
pkazi\_s\_20130320\_926.JPG

Levee Mile Report Line	50
Start Levee Mile	5.61
End Levee Mile	5.61
Location	Land Side
Category	
Item	Encroachments

Updated picture of debris and pruning on the landside toe of the levee looking upstream. This picture was taken during spring 2013 inspection.

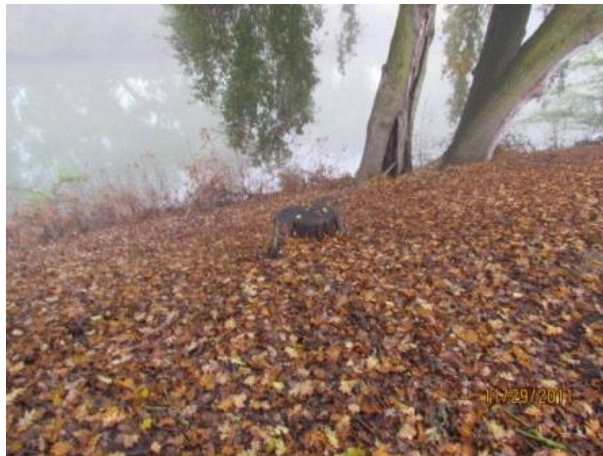
pkazi\_s\_20130304\_638.jpg

Levee Mile Report Line	51
Start Levee Mile	5.66
End Levee Mile	5.66
Location	Water Side
Category	
Item	Trim / Thin Trees

Tree stump was found on the waterside of the levee looking upstream.

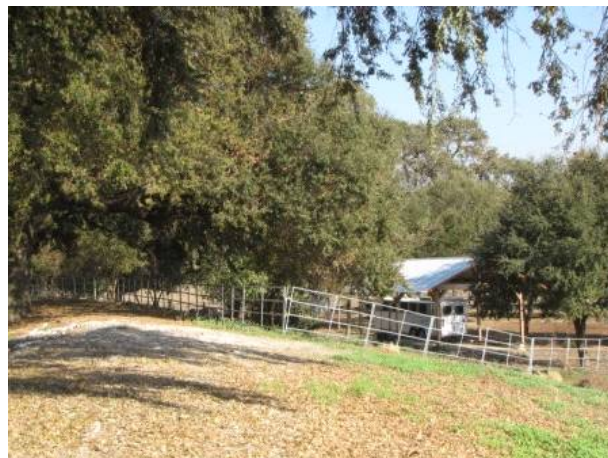
Levee Mile Report Line	55
Start Levee Mile	5.89
End Levee Mile	5.94
Location	Land Side
Category	
Item	Encroachments
View of fence around a horse pen along the shoulder of the levee and the landward slope.	
pkazi_s_20130304_622.jpg

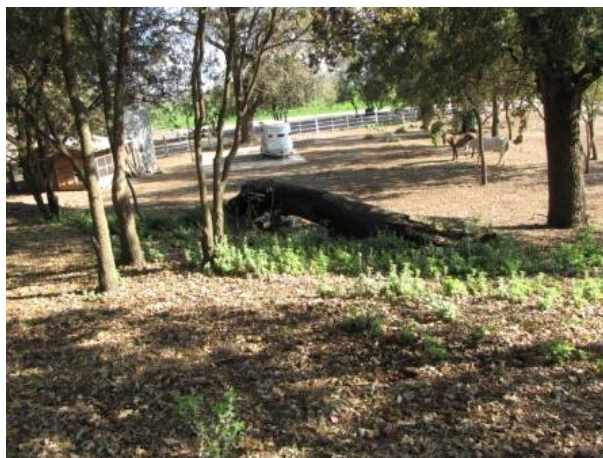
pkazi\_s\_20130304\_623.jpg

View of a tree trunk lying on the landward slope blocking visibility.

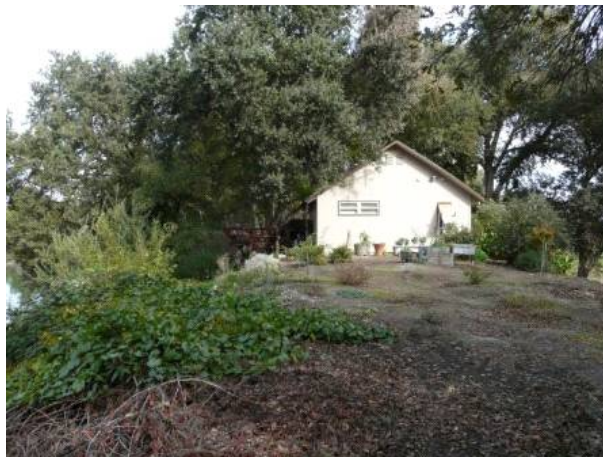
pkazi\_s\_20130304\_624.JPG

Levee Mile Report Line	57
Start Levee Mile	5.93
End Levee Mile	5.93
Location	Crown
Category	
Item	Encroachments

Building & associated landscaping on levee crown at LM 5.93.

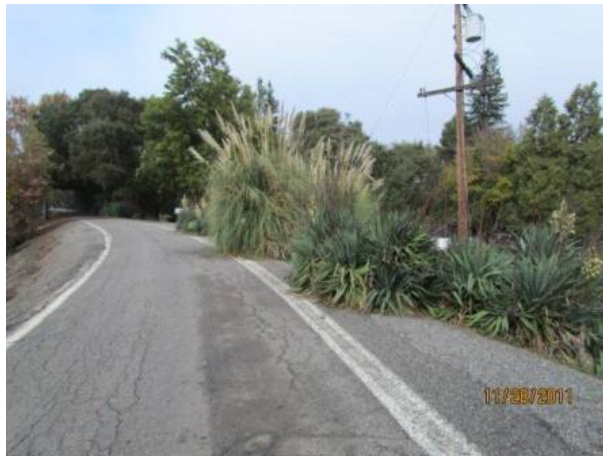
pkazi\_s\_20130304\_594.jpg

Levee Mile Report Line	58
Start Levee Mile	6.01
End Levee Mile	6.09
Location	Land Side
Category	
Item	Vegetation

Landscaping was found on the landside of the levee looking upstream.

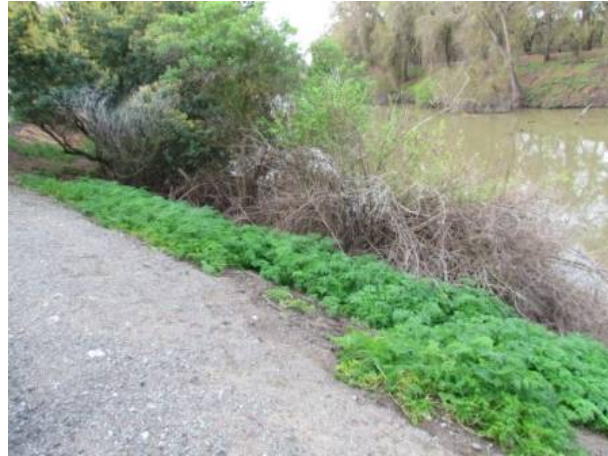
Levee Mile Report Line	59
Start Levee Mile	6.05
End Levee Mile	6.05
Location	Water Side
Category	
Item	Trim / Thin Trees
Tree trunks and vegetation was obstructing the visibility on the waterside slope of the levee looking downstream.	
pkazi_s_20130304_603.jpg

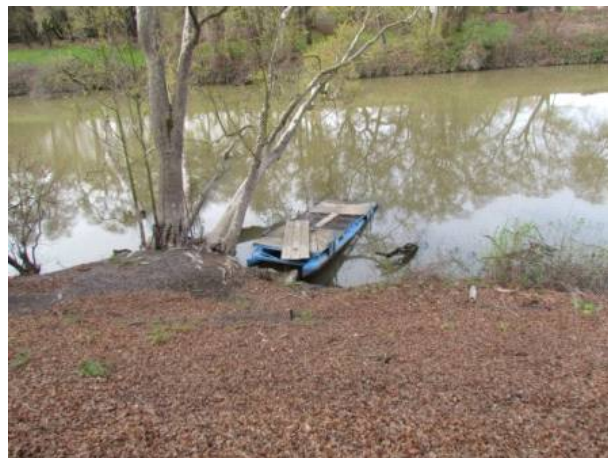
Levee Mile Report Line	61
Start Levee Mile	6.14
End Levee Mile	6.14
Location	Water Side
Category	
Item	Encroachments
An abandoned dock was found on the waterside of the levee looking upstream.	
pkazi_s_20130304_608.jpg

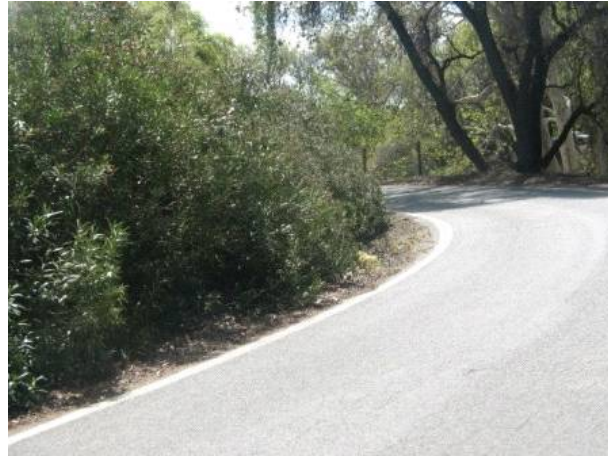
Levee Mile Report Line	63
Start Levee Mile	6.24
End Levee Mile	6.31
Location	Land Side
Category	
Item	Vegetation
Oleander on landward slope blocking view of levee from LM 6.24 to 6.32	
pkazi_s_20130304_596.jpg

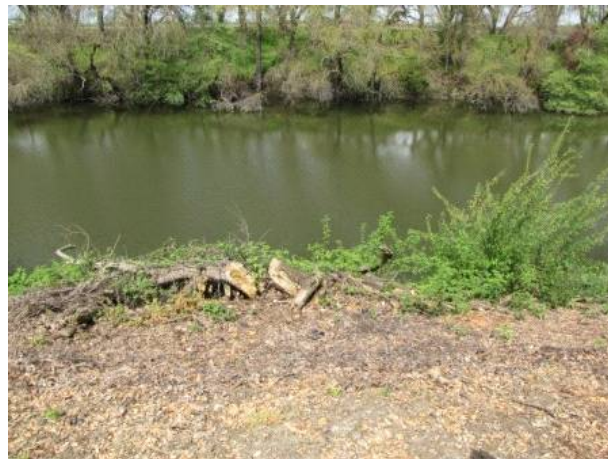
Levee Mile Report Line	64
Start Levee Mile	6.34
End Levee Mile	6.34
Location	Water Side
Category	
Item	Trim / Thin Trees
View of tree stumps on the waterward slope.	
pkazi_s_20130304_614.jpg

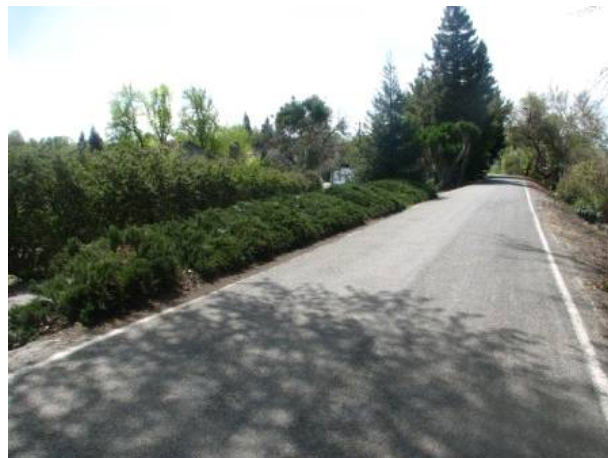
Levee Mile Report Line	66
Start Levee Mile	6.37
End Levee Mile	6.40
Location	Land Side
Category	
Item	Vegetation
Landscaping on landward slope blocking view from LM 6.37 to 6.40	
pkazi_s_20130304_597.jpg

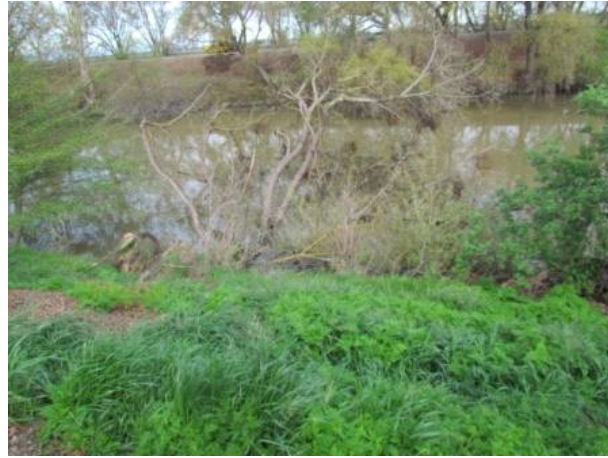
pkazi\_s\_20130304\_631.jpg

Vegetation on the waterside of the levee looking downstream.

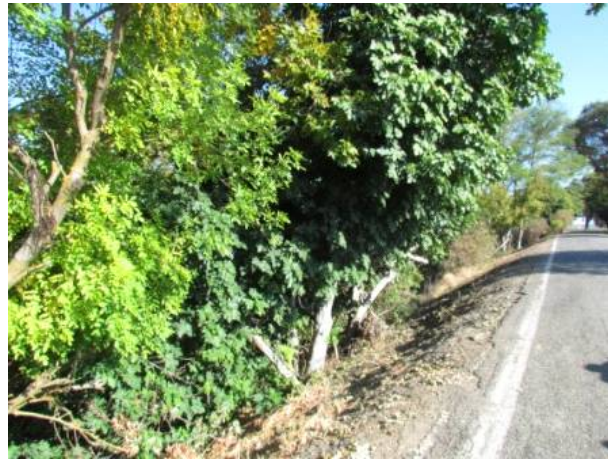
pkazi\_s\_20130304\_632.jpg

Levee Mile Report Line	67
Start Levee Mile	6.49
End Levee Mile	6.49
Location	Water Side
Category	
Item	Trim / Thin Trees

Tree was blocking the visibility on the waterside of the levee looking upstream. This picture was taken during fall 2012 inspection.

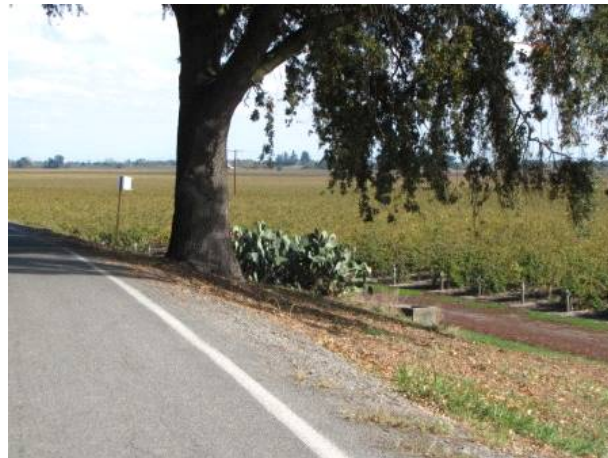
pkazi\_s\_20130304\_626.jpg

Levee Mile Report Line	68
Start Levee Mile	6.56
End Levee Mile	6.56
Location	Land Side
Category	
Item	Vegetation

View of landscaping along the landward slope.

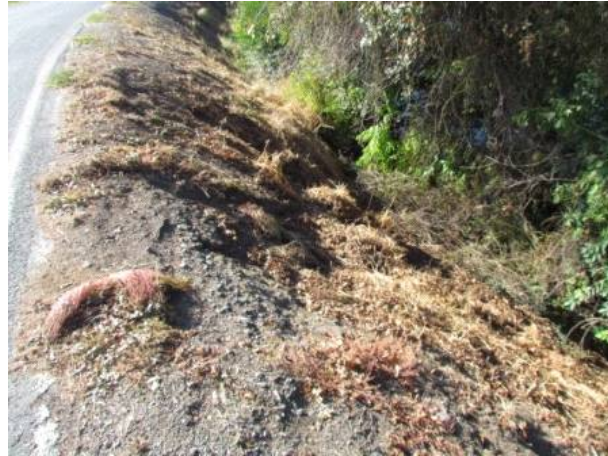
pkazi\_s\_20130304\_607.jpg

Slope instability was found on the waterside of the levee looking downstream.

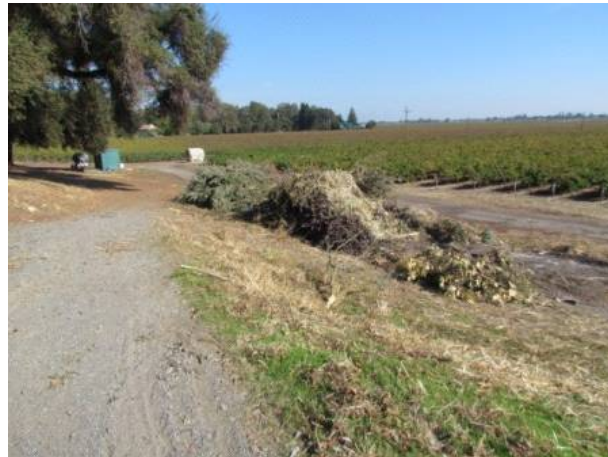
pkazi\_s\_20130304\_647.jpg

Levee Mile Report Line	70
Start Levee Mile	6.64
End Levee Mile	6.64
Location	Land Side
Category	
Item	Encroachments

Pruning was found on the landside of the levee looking upstream.

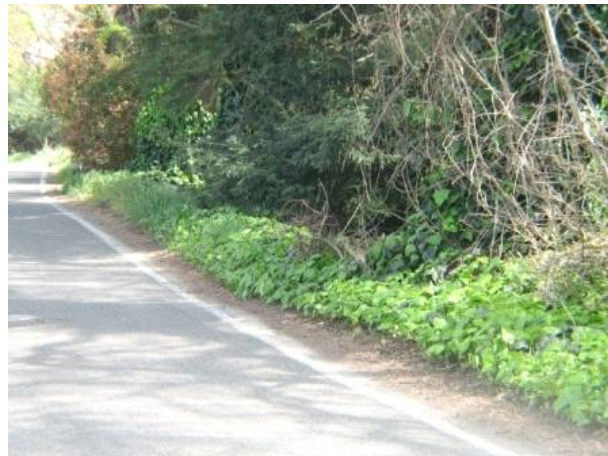
pkazi\_s\_20130304\_600.jpg

Landscaping on landward slope blocking view from LM 6.87 to 6.95

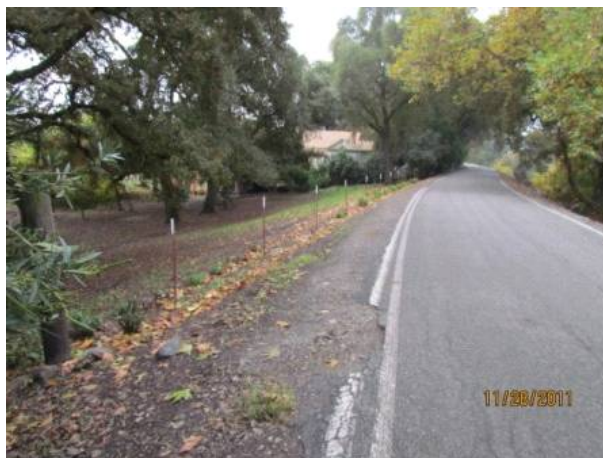
Levee Mile Report Line	72
Start Levee Mile	6.93
End Levee Mile	6.95
Location	Land Side
Category	
Item	Encroachments
Fence was found on the landside of the levee looking downstream.	
pkazi_s_20130304_586.jpg

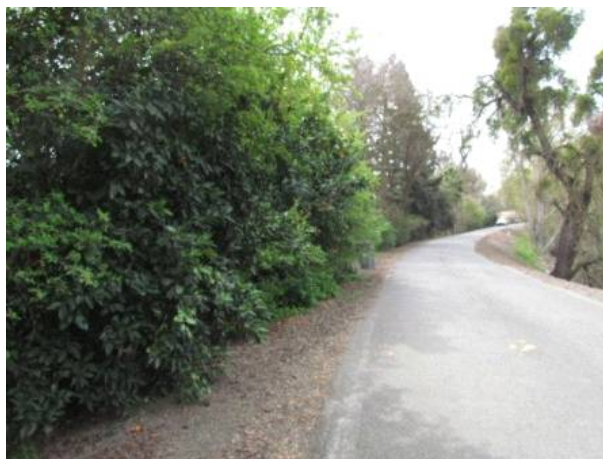
Levee Mile Report Line	73
Start Levee Mile	6.98
End Levee Mile	7.04
Location	Land Side
Category	
Item	Vegetation
View of the landscape on the landside shoulder of the levee looking downstream.	
pkazi_s_20130320_928.JPG

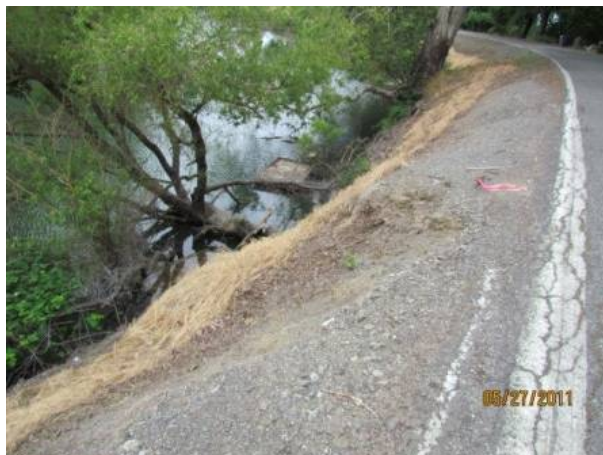
Levee Mile Report Line	75
Start Levee Mile	7.02
End Levee Mile	7.02
Location	Water Side
Category	
Item	Erosion / Bank Caving
Updated erosion site picture on the waterside slope of the levee looking upstream during Spring 2011 inspection.	
pkazi_s_20130304_627.jpg

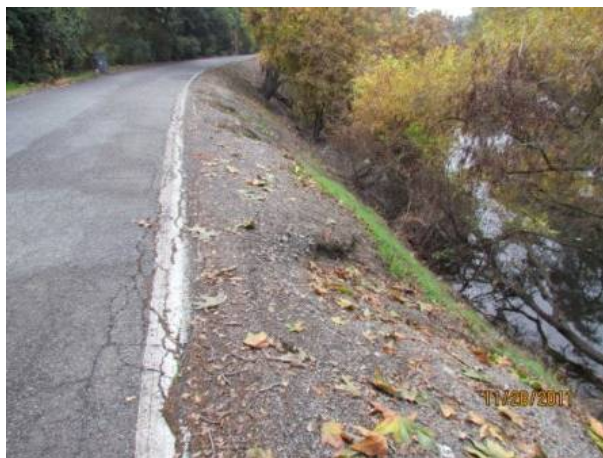
pkazi\_s\_20130304\_628.jpg

Erosion was found on the waterside of the levee looking downstream. This picture was taken during fall 2011 inspection.

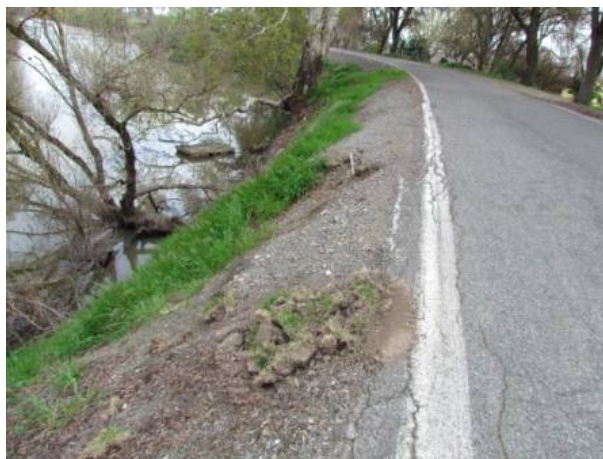
pkazi\_s\_20130304\_629.jpg

Levee Mile Report Line	75
Start Levee Mile	7.02
End Levee Mile	7.02
Location	Water Side
Category	
Item	Erosion / Bank Caving

Erosion on the waterside of the levee looking upstream. This picture was taken during spring 2012 inspection.

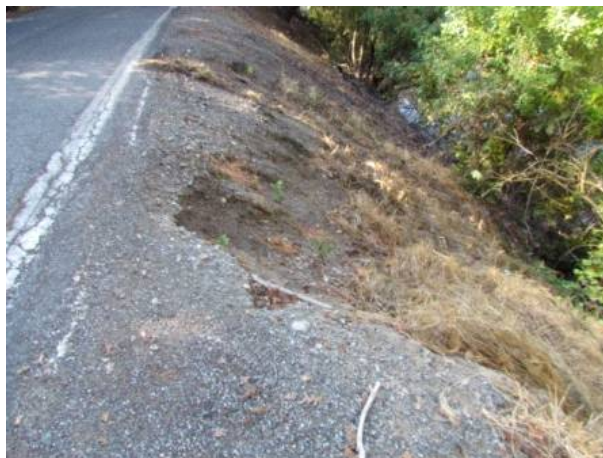
pkazi\_s\_20130304\_630.jpg

Levee Mile Report Line	75
Start Levee Mile	7.02
End Levee Mile	7.02
Location	Water Side
Category	
Item	Erosion / Bank Caving

Erosion was found on the waterside slope of the levee looking downstream. This updated picture was taken during fall 2012 inspection.

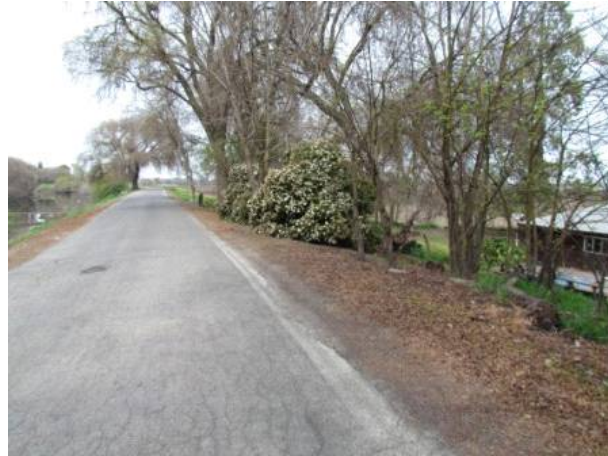
pkazi\_s\_20130320\_929.JPG

Landscaping was found on the landside shoulder of the levee looking upstream.

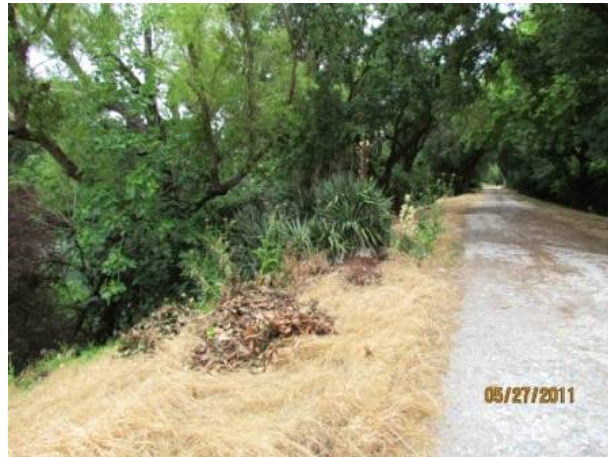
pkazi\_s\_20130304\_634.jpg

Levee Mile Report Line	77
Start Levee Mile	7.39
End Levee Mile	7.39
Location	Water Side
Category	
Item	Vegetation

Landscaping on the waterside of the levee. The picture was taken from the crown looking upstream.

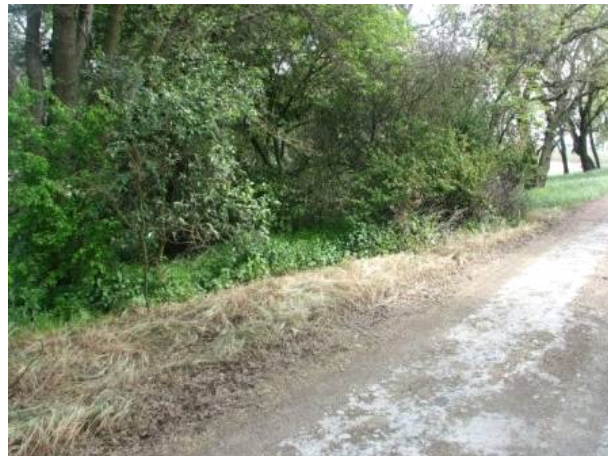
pkazi\_s\_20130304\_601.jpg

Levee Mile Report Line	78
Start Levee Mile	7.42
End Levee Mile	7.47
Location	Land Side
Category	
Item	Vegetation

Landscaping on landward slope blocking view from LM 7.42 to 7.47

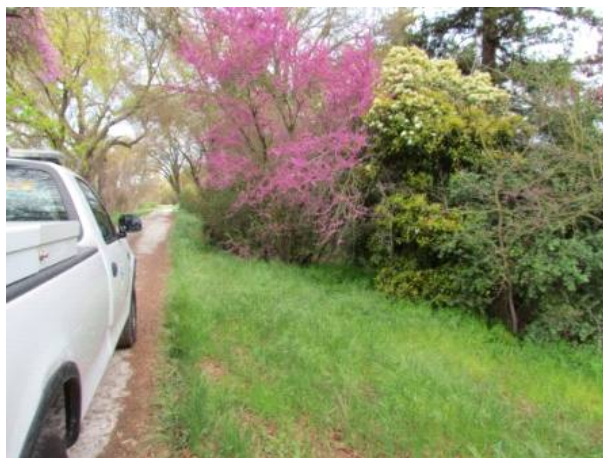
pkazi\_s\_20130304\_602.jpg

Vegetation on the landside of the levee looking upstream. This picture was taken during spring 2012 inspection.

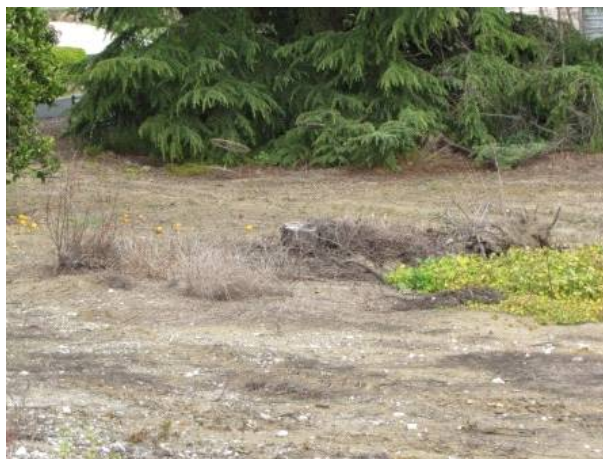
pkazi\_s\_20130304\_633.jpg

Levee Mile Report Line	79
Start Levee Mile	7.50
End Levee Mile	7.50
Location	Land Side
Category	
Item	Trim / Thin Trees

View of a tree stump on the landward slope.

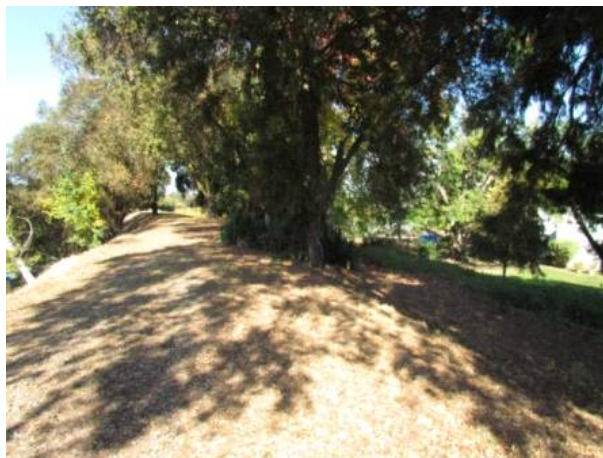
pkazi\_s\_20130304\_655.jpg

Levee Mile Report Line	80
Start Levee Mile	7.54
End Levee Mile	7.54
Location	Land Side
Category	
Item	Vegetation

Landscaping was found on the landside shoulder of the levee looking upstream.

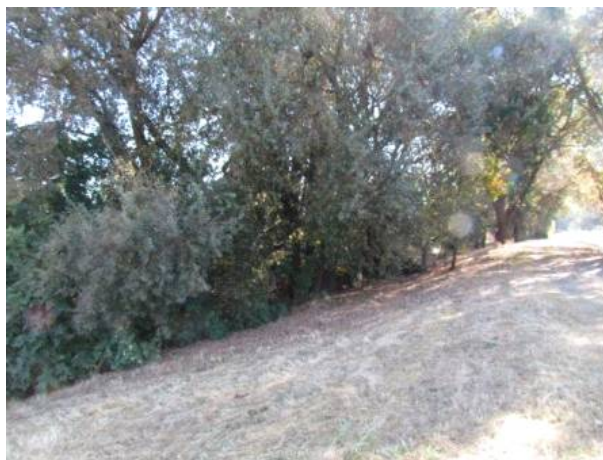
pkazi\_s\_20130304\_665.jpg

Landscaping was blocking the visibility on the landside of the levee looking downstream.

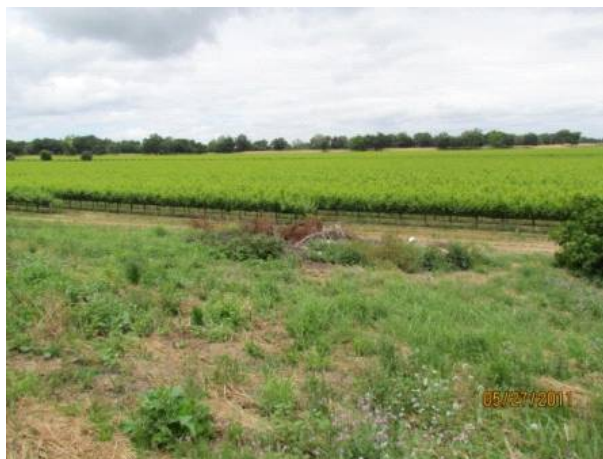
pkazi\_s\_20130304\_666.jpg

Levee Mile Report Line	82
Start Levee Mile	7.60
End Levee Mile	7.60
Location	Land Side
Category	
Item	Encroachments

Prunings located on the toe of landward side of the levee. The picture was taken from the crown looking upstream.

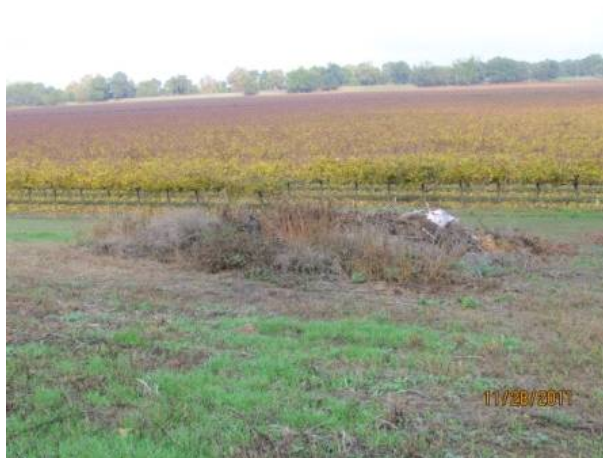
pkazi\_s\_20130304\_667.jpg

Levee Mile Report Line	82
Start Levee Mile	7.60
End Levee Mile	7.60
Location	Land Side
Category	
Item	Encroachments

Prunings were found on the landside of the levee looking upstream. This picture was taken during fall 2011 inspection.

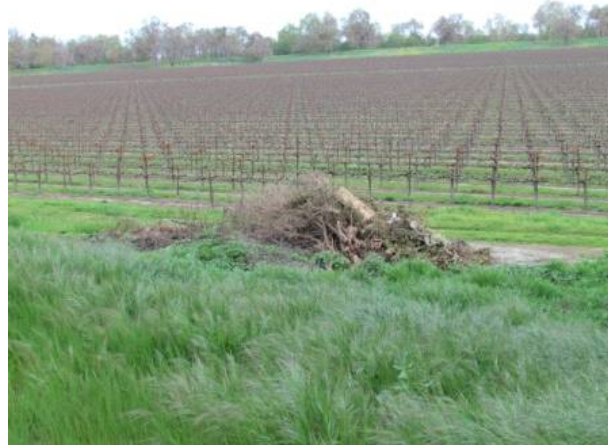
pkazi\_s\_20130304\_668.jpg

Prunings were found on the landside of the levee looking upstream.

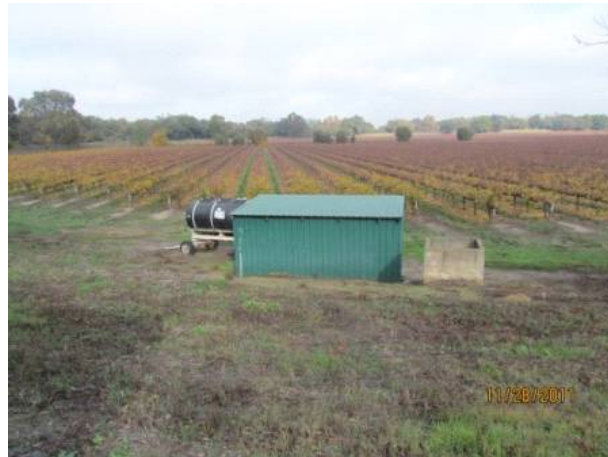
pkazi\_s\_20130304\_590.jpg

Levee Mile Report Line	85
Start Levee Mile	7.82
End Levee Mile	7.82
Location	Land Side
Category	
Item	Encroachments

Equipment was found on the landside of the levee looking upstream.

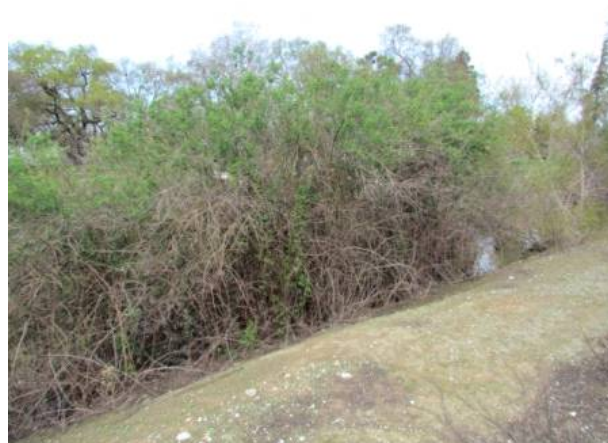
pkazi\_s\_20130304\_656.jpg

Levee Mile Report Line	87
Start Levee Mile	7.86
End Levee Mile	7.86
Location	Water Side
Category	
Item	Trim / Thin Trees

Tree branches were blocking the visibility of the waterside of the levee looking upstream.

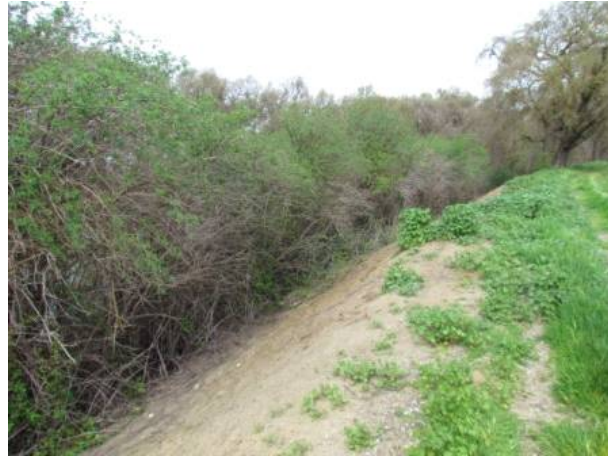
pkazi\_s\_20130320\_930.JPG

Trees were obstructing the visibility on the waterside toe of the levee looking upstream. This picture was taken during spring 2013 inspection.

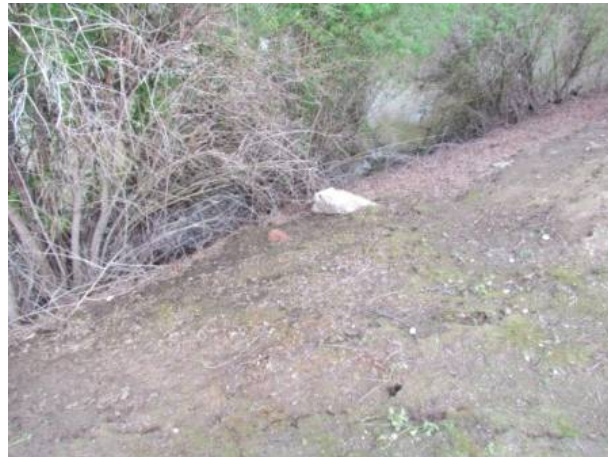
pkazi\_s\_20130304\_657.jpg

Levee Mile Report Line	89
Start Levee Mile	8.05
End Levee Mile	8.05
Location	Water Side
Category	
Item	Encroachments

An abandoned pipe was found on the waterside of the levee looking upstream.

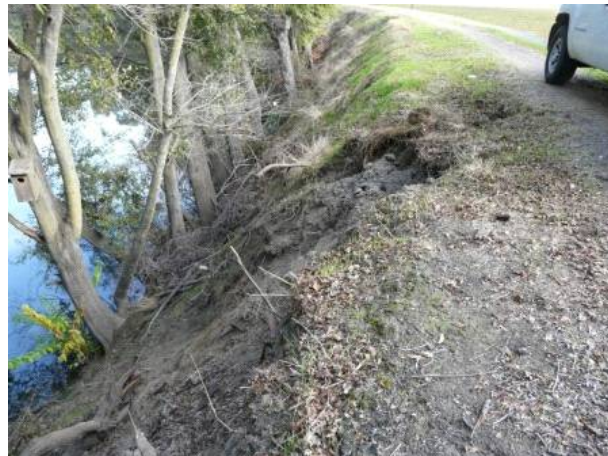
pkazi\_s\_20130304\_635.JPG

Levee Mile Report Line	90
Start Levee Mile	8.46
End Levee Mile	8.46
Location	Water Side
Category	
Item	Erosion / Bank Caving

Repair erosion on waterward slope near shoulder at LM 8.46.

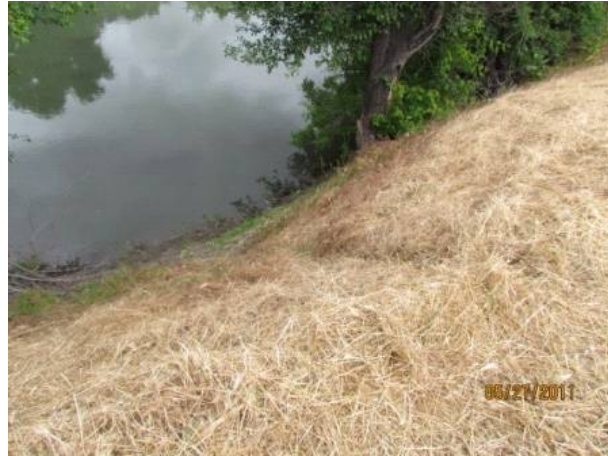
pkazi\_s\_20130304\_636.jpg

Slope instability on the waterside slope of the levee. The picture was taken from the crown looking upstream.
